RECORDS
OF
STEAM BOILER EXPLOSIONS,

BY
EDWARD BINDON MARTEN,

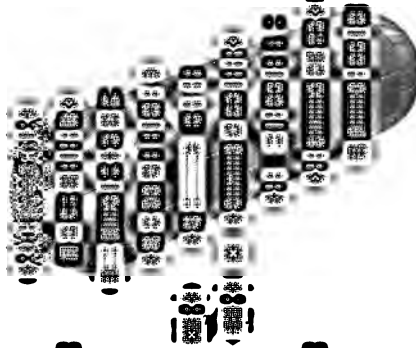
and wagon boilers, and are
 pressure like drum heads,
 they also require long stays
 are subject to so much
 and for long together,
 and cotters.
 always being sprung by
 or less spherical shape,
 this consideration no
 spherical, as shown in

and no other form of boiler, as the whole of the boiler has no tendency to warp or model exhibited. The surface of the plain boiler is so easily cleaned and worked at every part and is equally to view. The boilers externally are cleaned by the action of steam from accumulators and are prevented from rusting by the direct action of steam as 70 or 80 feet, as in the case of last furnaces, these are "overheated," owing to the intense flame for its effect. The boiler by exposure to the heat of the furnace have a succession of small cracks, and where great length is required, the extreme length of the boiler is not until the ends met

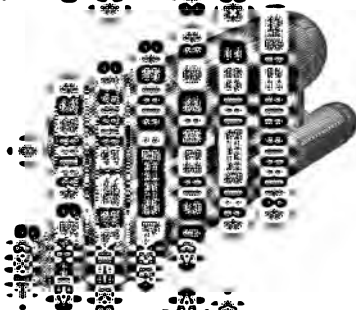
meter for plain cylindrical
boilers have been used
ever by a combination of
of these known as the
in France that it is
is shown in Fig. 29,

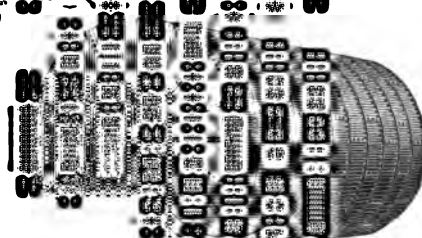
shown in one flat piece, as the main body of the boiler with the bottom and top head taken away. Several of the forms of construction known as the wagon-shaped end over

a plain cylindrical shell generate steam very rapidly; when placed over the fire and along the length of the tube the front end of the tube widens into a large, rounded fireplace, has led to the form now made of this form. The first boiler of this form in Edinburgh in 1821 was of a wagon-topped fireplace form of boiler occurred in 1854, and at the present time is facing the fire inside the

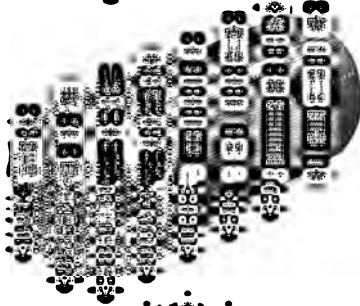
ed in Cornwall gave
 eding good duty
 ve them the most
 great number of
 that have happened,
 the boiler shown in
 increased but the

diameter in the same
 the two-tube boiler,
 along various particular
 made to unite into
 what is known
 40, and in other

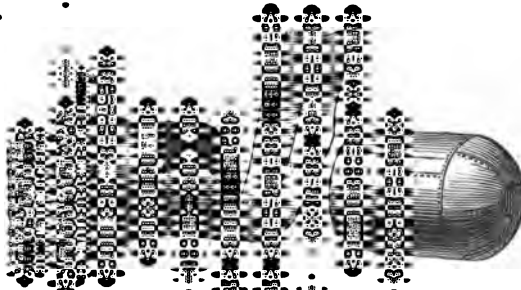
distance, shortness of
 Abercarn in 1865,
 the, which collapsed
 the and the sides of
 the, although exposed
 worked through the
 In this case the
 the tube, and not
 that if a boiler runs
 boiler, there must
 be with any other
 low-off pipe or any
 out of shape upon
 would happen. If
 the feed were turned
 to the fire would
 the subsidence of the
 hot-hot, and so much
 bearing the pressure,
 twice, in the present
 line, as shown in

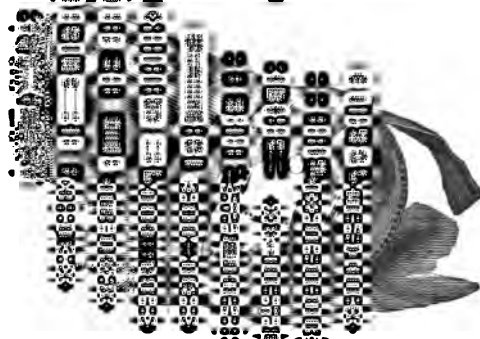
2 killed, 18 injured.

6in. diameter, tubes
fitted with steam gauge,
and worked at
lbs., and had been at

the shell were torn off
partly round, and moved

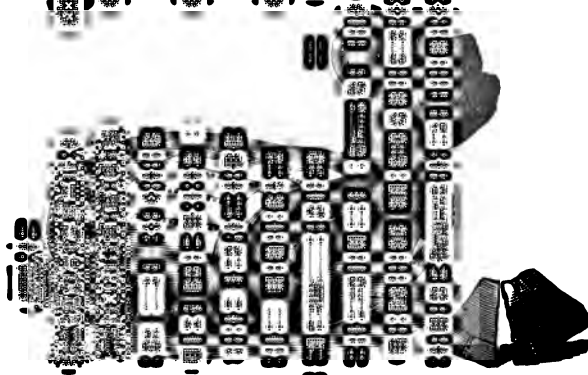
meter, $\frac{5}{8}$ inch plates, the pressure.

during the time another boiler was required under the balloon, and the water was required from it into the other boiler, and it had become fast, and

the bottom gave

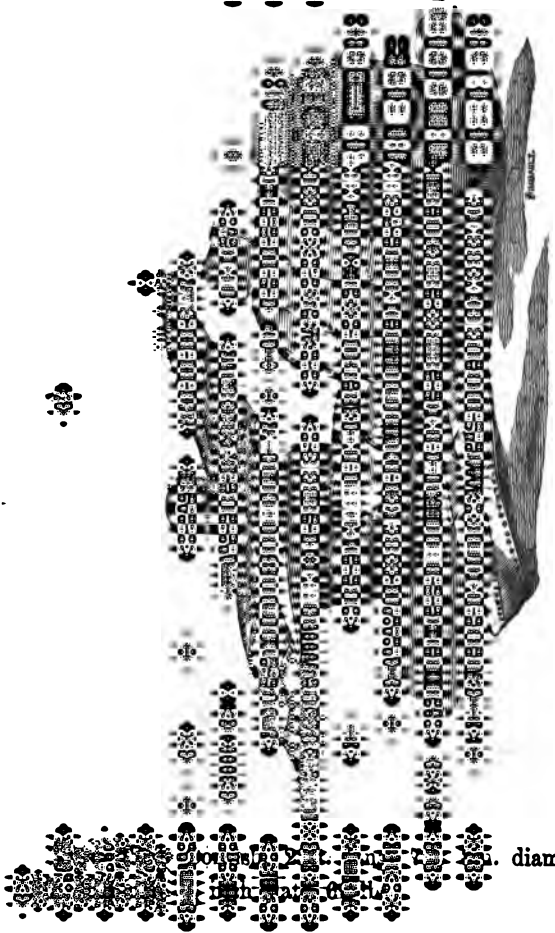
Fig. 22.

water, and the main bulk
air to a great height,

2 killed, 30 injured.

diameter, with tubes,

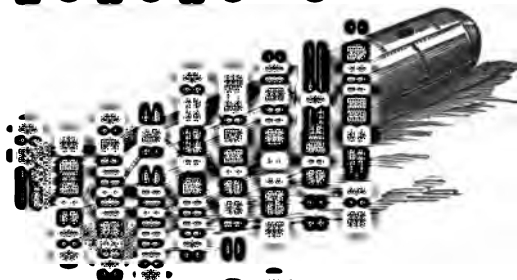
to a knife edge all along

2 killed, 1 injured.

diameter, plates $\frac{3}{8}$ inch,
a new plate had lately
rent, and back end
explosion was deterioration

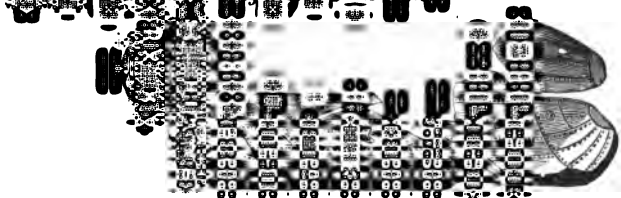
the front by four
exceedingly weak shape
were not attached
collapsed upwards,
to violently escape.
than usual at
unsafe, even at the

2 killed.

diameter, $\frac{3}{8}$ inch
ed longitudinally.
incised, and gave
torn into 4 pieces,
